Environmental Assessment
Determinations and Compliance Findings for HUD-assisted Projects
24 CFR Part 58

Project Name: PR-CRP-000700- “PARQUE URBANO CANOBANAX”

Project is located at the corner of Muñoz Rivera Street and Blanco Sosa Street, Pueblo Ward, Canóvanas, Puerto Rico. NAD 83 (Lat: 18.37911442°, Lon: -65.89995307°). Cadastral No. 089-086-016-01. (See Location Map attached at Attachment A of this report.)

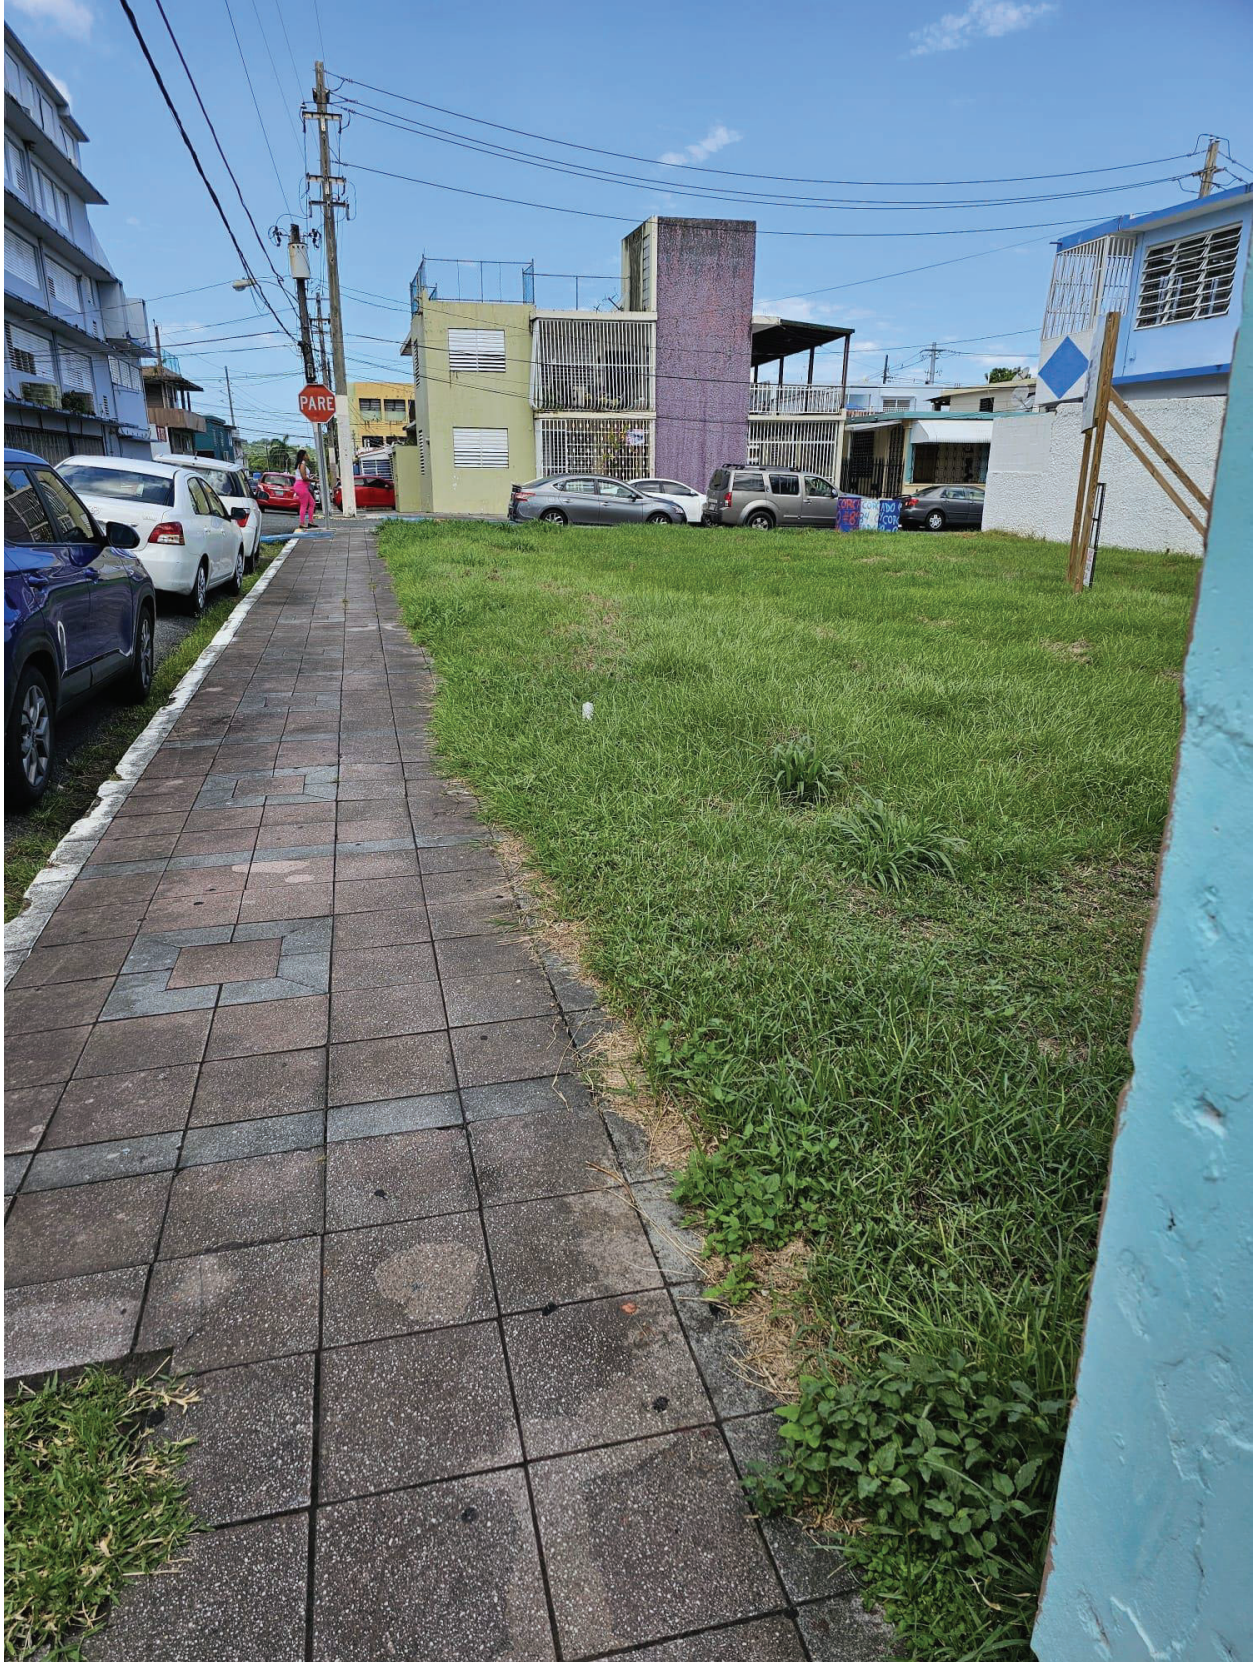
Photograph 2 – Subject/Target property western boundary. Looking south to north.

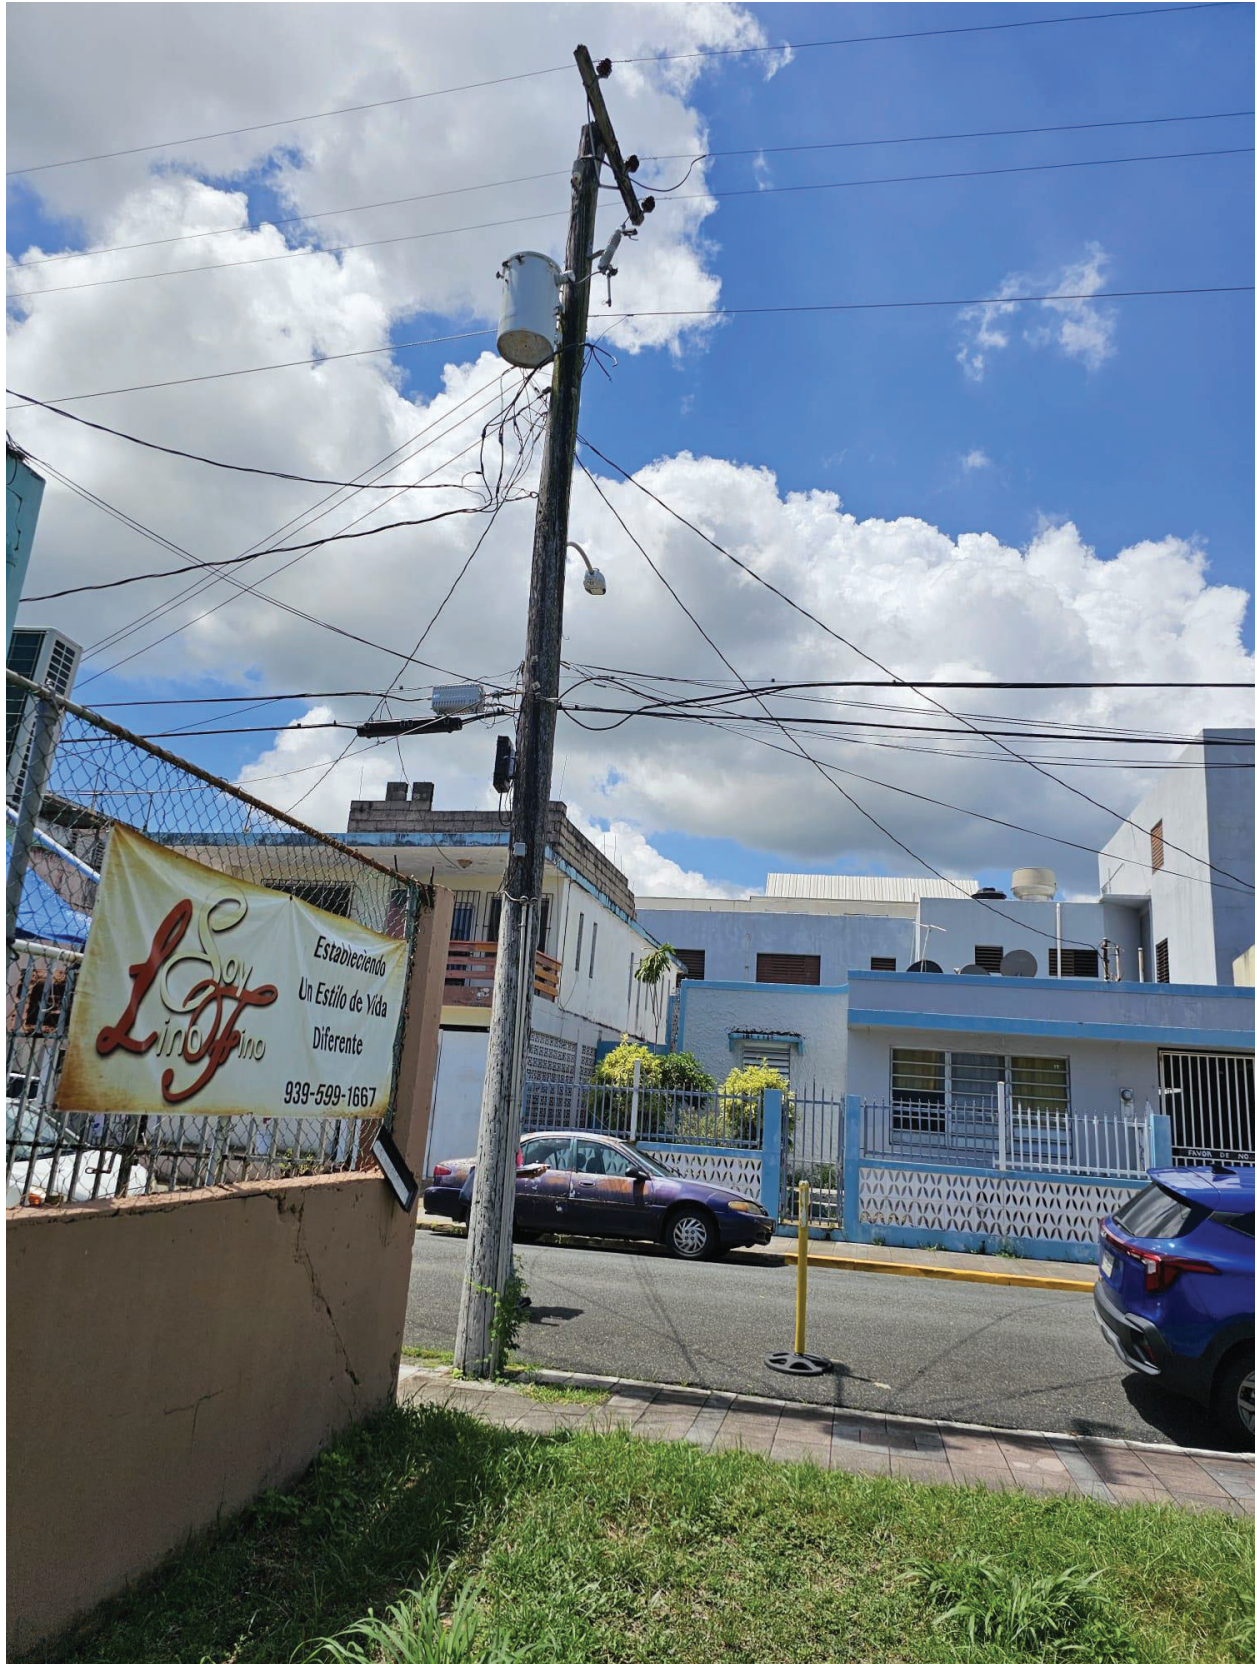
Photograph 5 – Electric transformer at pole located at the southwestern corner.

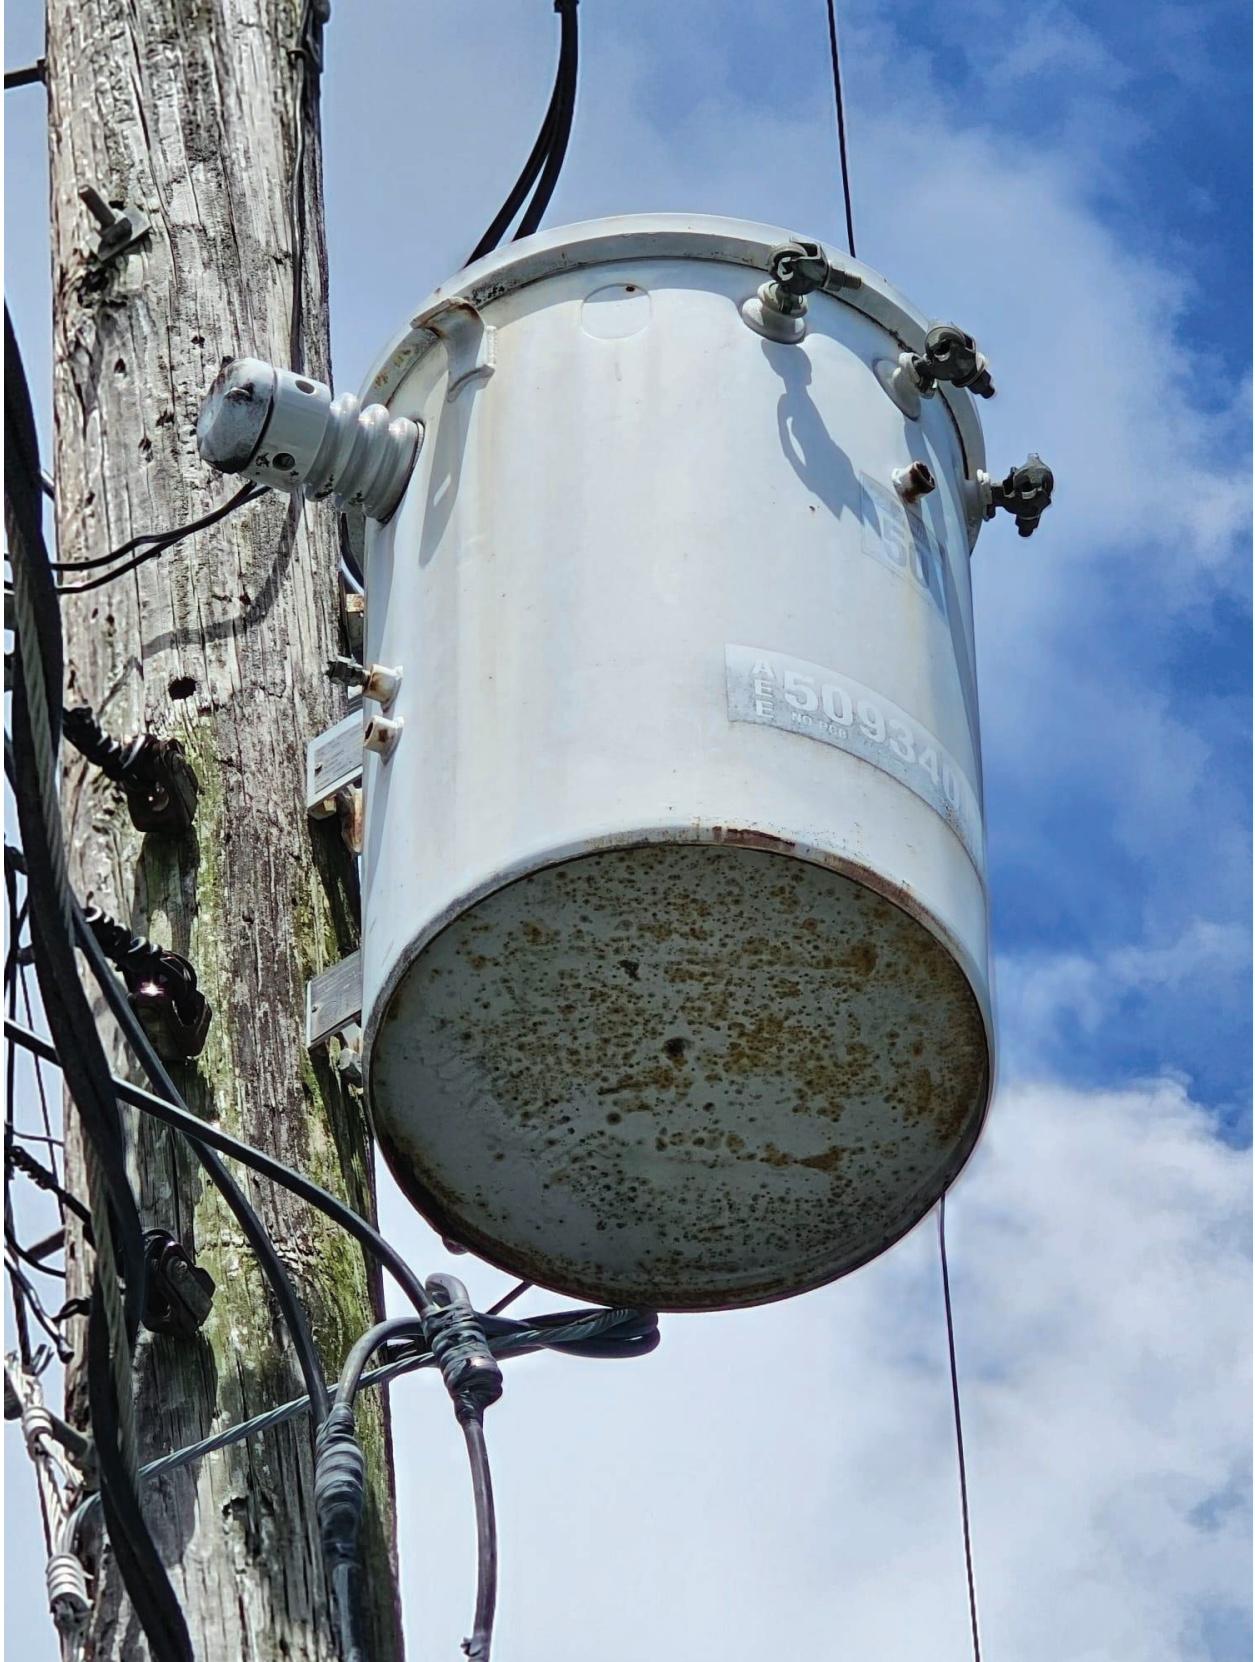
Photograph 6 – Electric transformer with faded No PCB sign.

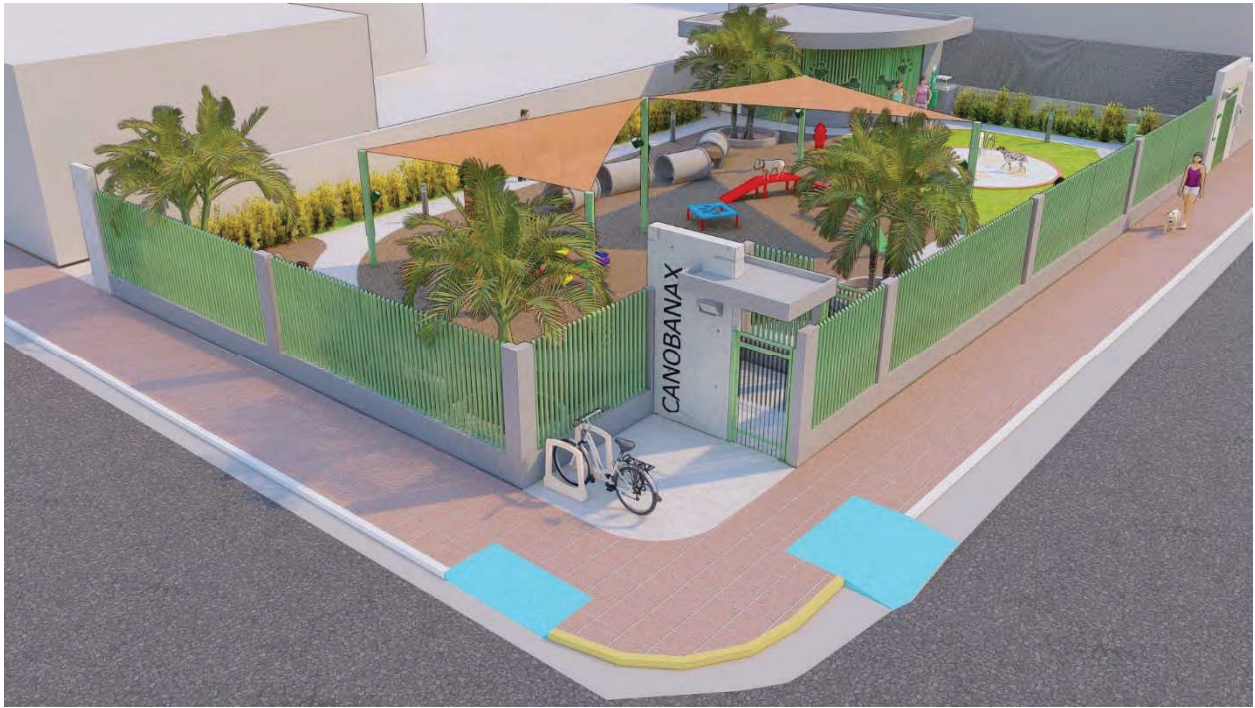
3D View of proposed project 1

- Storage & pet washing station – 1'-6" deep
- 5 Poles for the shading sails – 4' deep
- Fences – 3' deep
- Play elements for pets – 2' deep
- Trench for electric conduits – 3' deep
- Trench for water distribution – 2' deep
- Trench for sanitary pipes – 3' deep

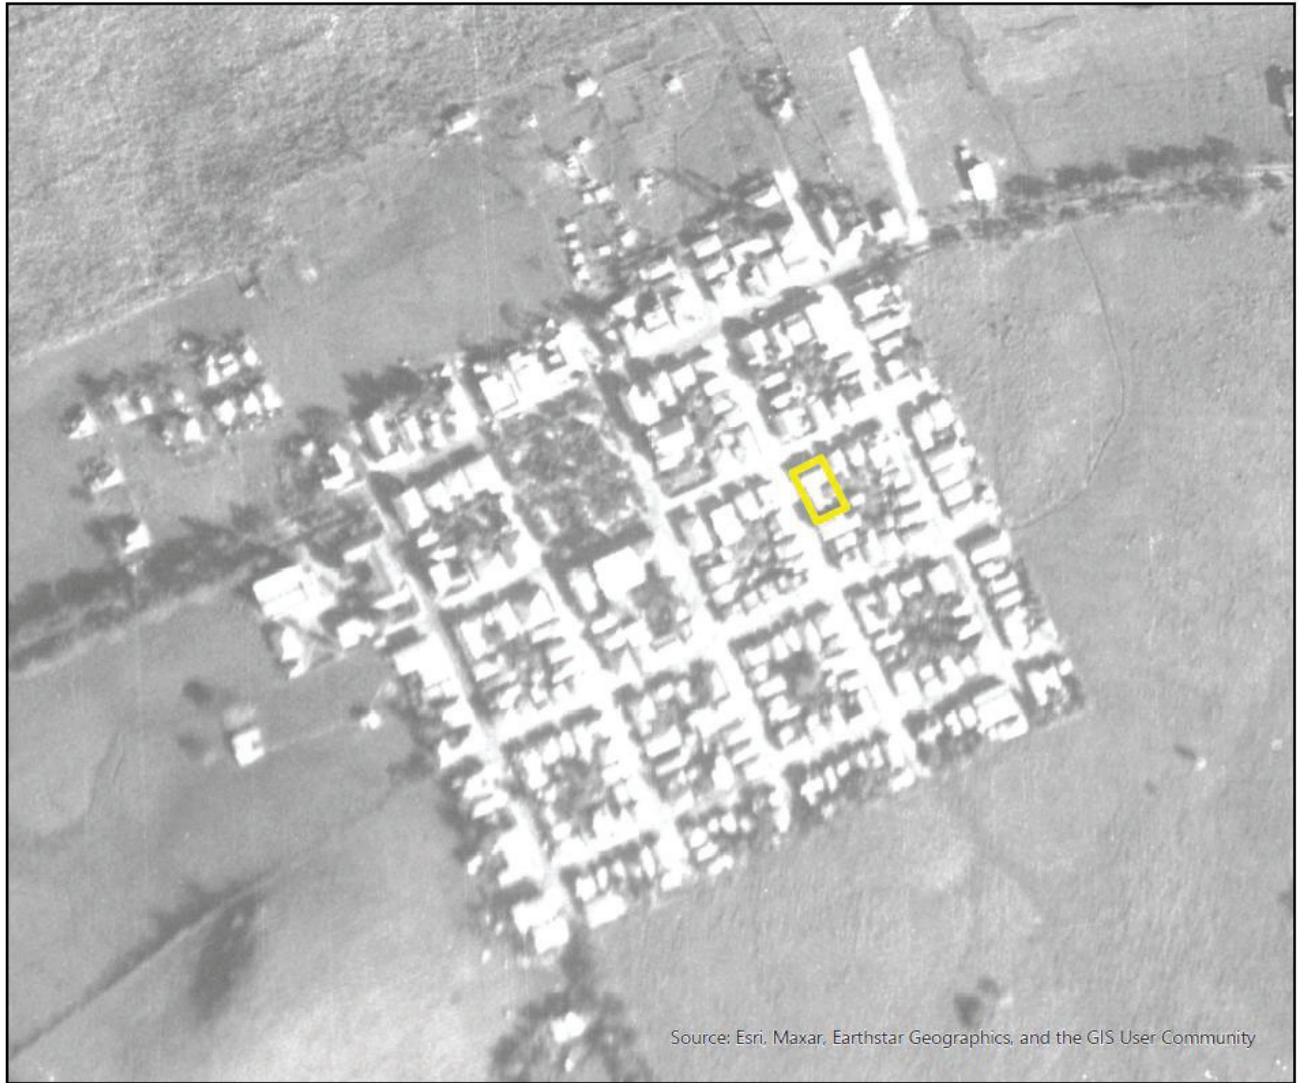
Figure 5. 1937 aerial photograph of the urban area Canóvanas. The project parcel location is highlighted in yellow (Source: DTOP, PR, georeferenced in ArcGIS, 2025).

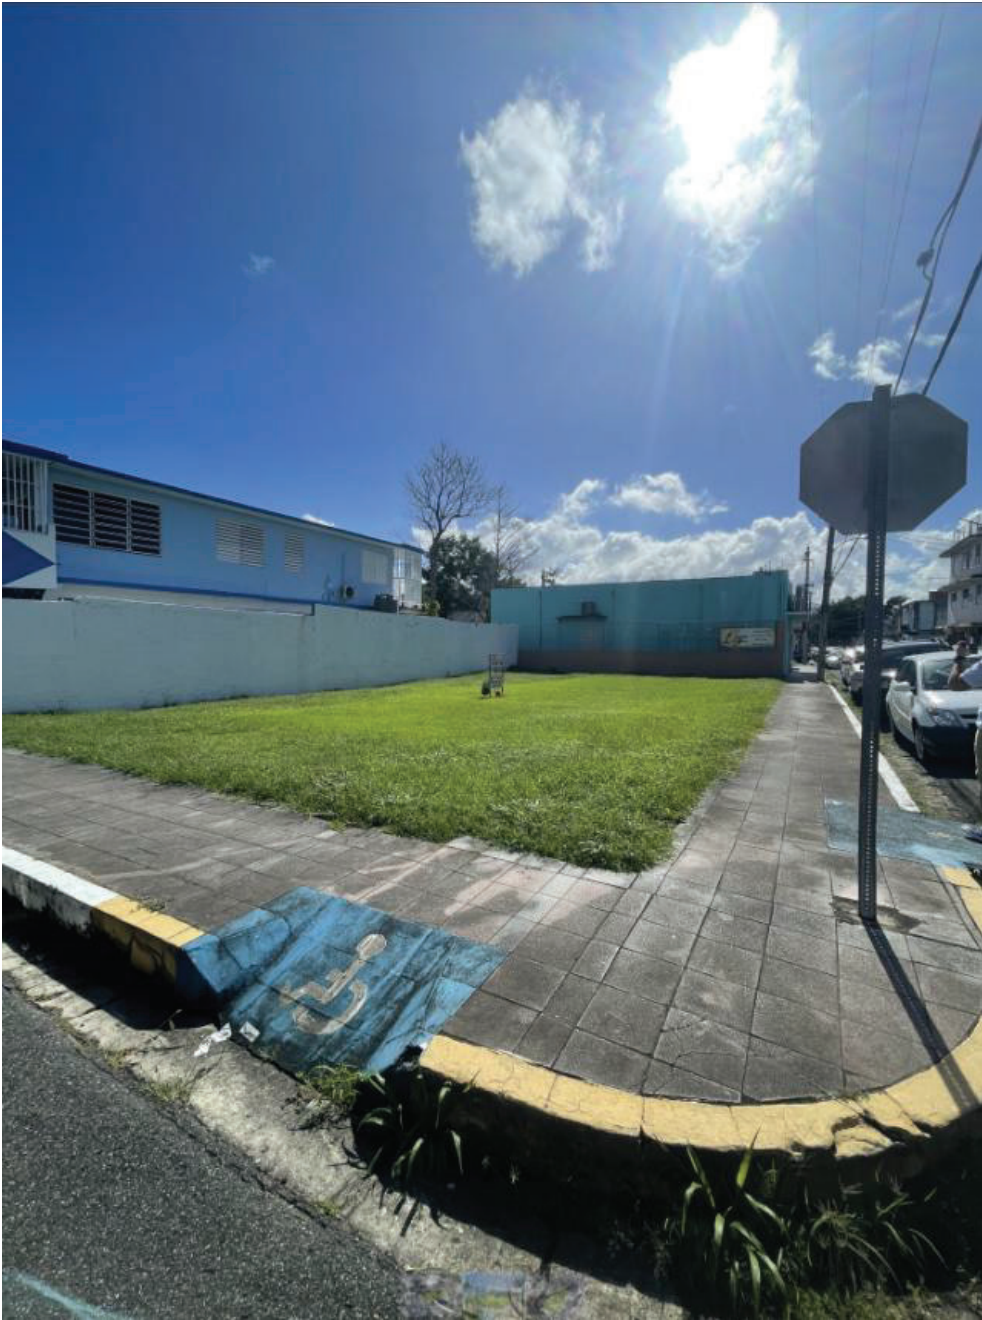
Figure 11. Site conditions, general view. (Source: Hernández-Bauzá PSC Architects, 2025).

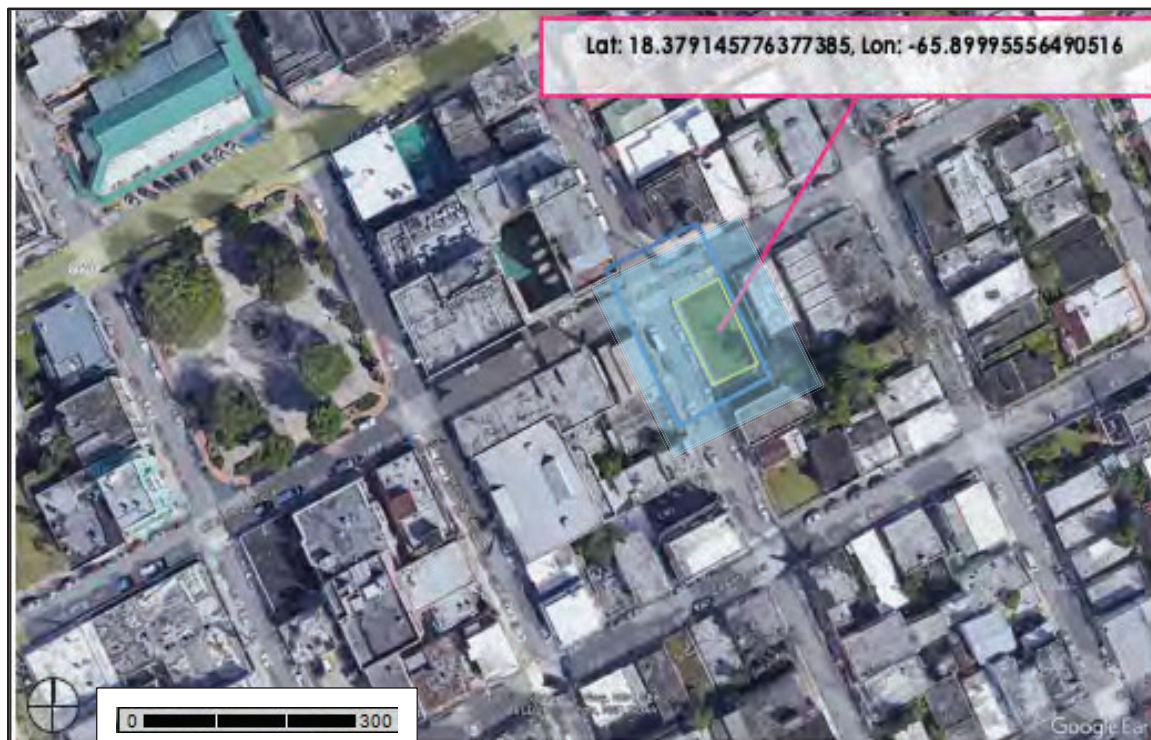
Figure 2
Modified scale

Actual block conditions can be appreciated. Contrary to the original block design, which had chamfered corners and well-defined and contained interior patios (refer to USGS 1941 map), some structures have modifications that have extended upon the back patios.
